Maritime archaeological analysis of two historic shipwrecks located during the MH370 aircraft search

Ross Anderson

April 2018

Report No. 322—-Department of Maritime Archaeology
Western Australian Museum

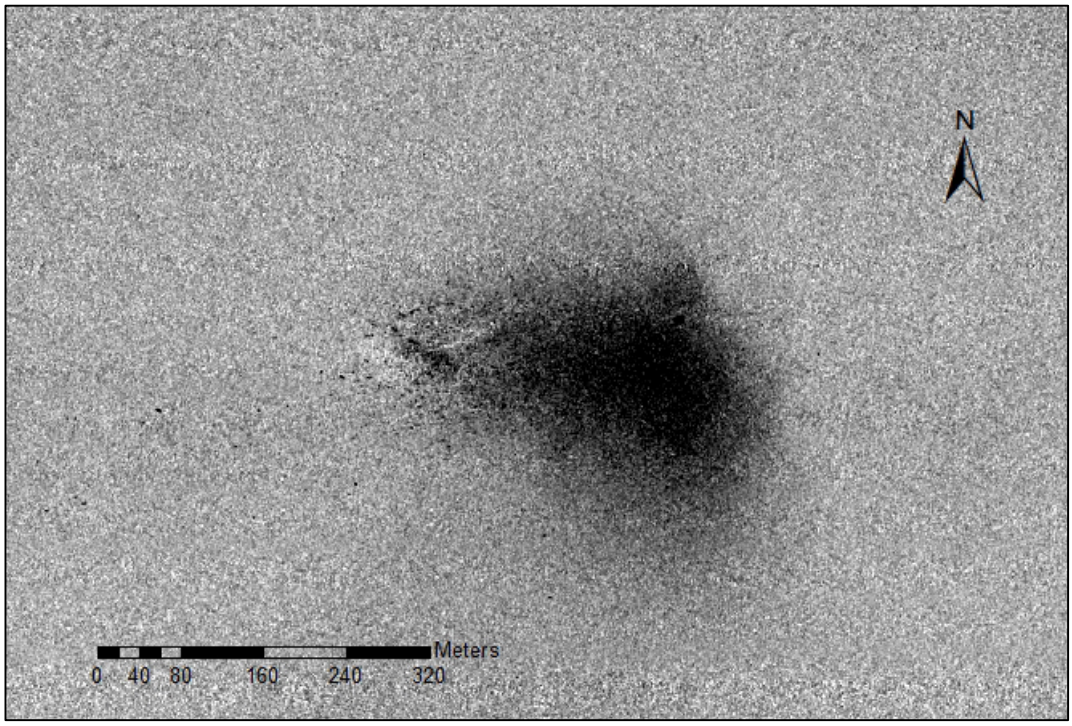
Figure 3 GIS map showing sonar image of IOS-001 shipwreck site scattered over a wide area of seabed in 3900 m depth (Fugro/ATSB/ WA Museum).

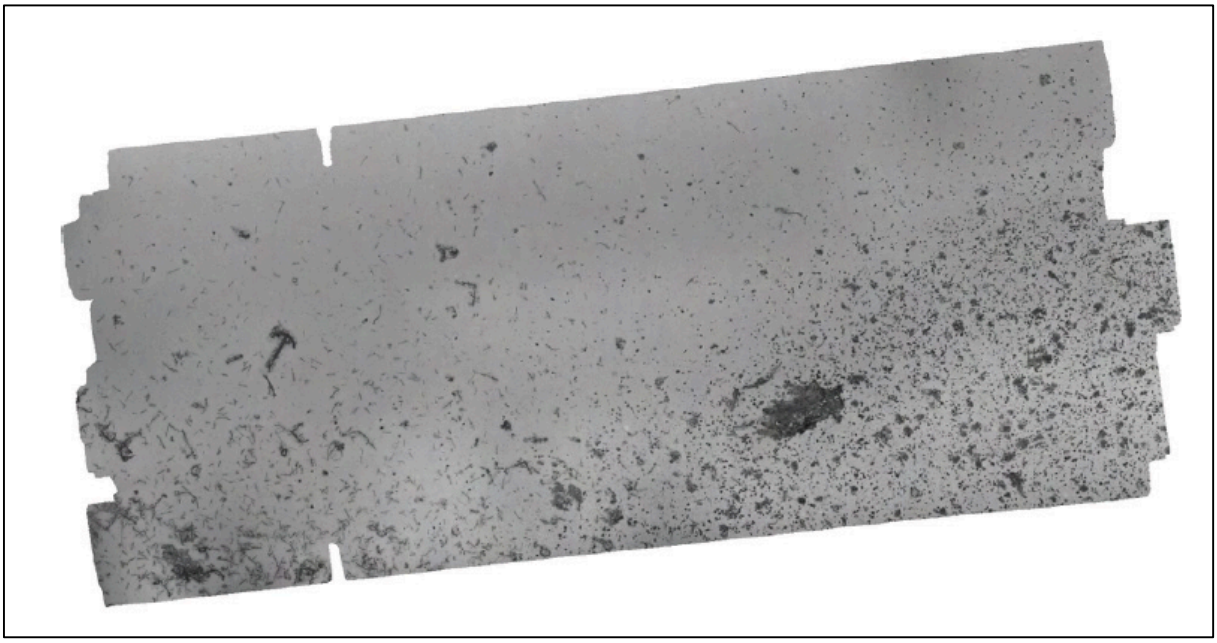
Figure 4 Orthographic projection of 3D mosaic showing part of IOS-001 site, with Anchor 1 and water tank visible along with coal and scattered fastenings (Australian Centre for Field Robotics, University of Sydney).

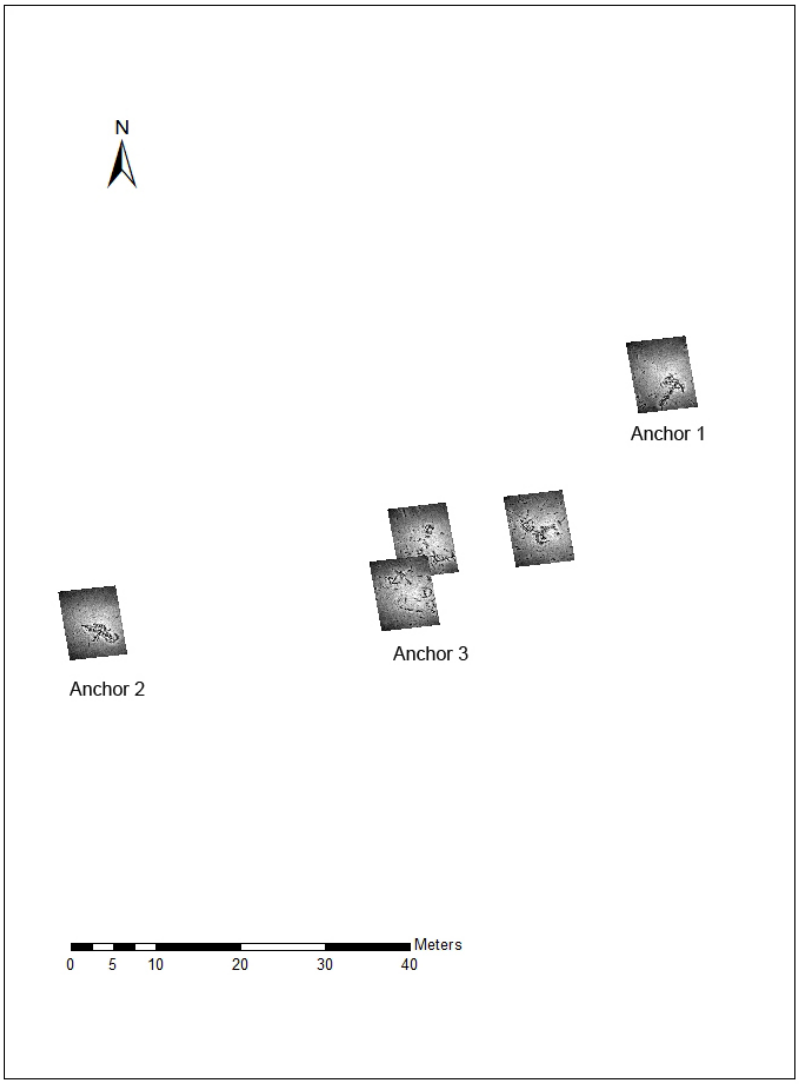
Three anchors of different sizes have been identified on the site (Figure **12**). All anchors are Admiralty type anchors with a curved crown, consistent with a post-1830s date. Pering's Improved Anchor patented in 1835 featured a curved crown (Curryer 1999: 76), while the Board of Admiralty 1841 Pattern anchor features a 'graceful elliptical curve' (ibid: 83-84). Anchors 1 and 3 have folding iron stocks. Wooden stocks were still used on vessels up until the 1850-60s, gradually being phased out by the use of iron stocks, including folding stocked anchors. A distance of 60m separates Anchor 1 and Anchor 2. Anchor 3 lies approximately in between with Anchor 1 and Anchor 2 lying 31m and 27m from Anchor 3, respectively (Figure **12**).

Figure 12 Georeferenced photographs showing relative positions of anchors on IOS-001 site (Fugro/ATSB/ WA Museum).

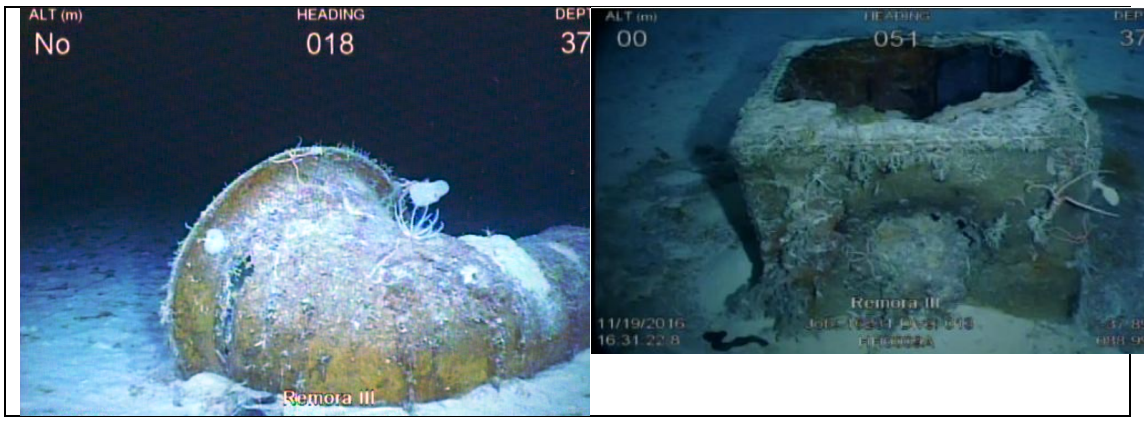
Figure 32 Ship's ventilator and iron tank in Area HH0009A (ATSB)

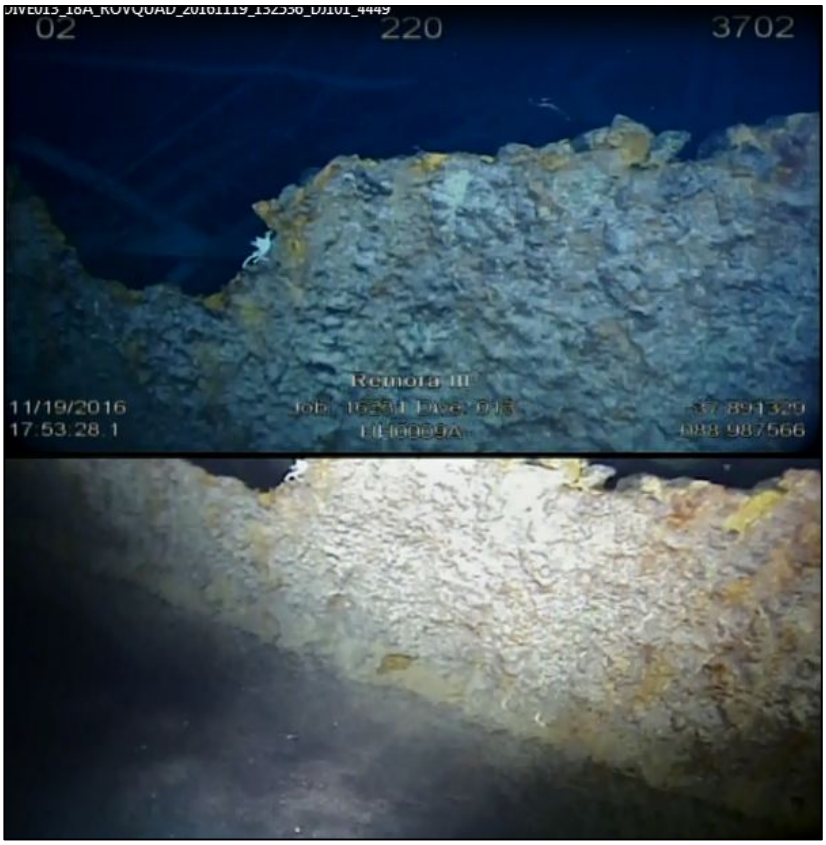
one area the hull plating shows evidence of ragged edges and extensive surface corrosion products, which may be an indication of heat or fire damage (Figure 48). This phenomenon has been observed on the HMAS *Sydney II* shipwreck relating to fires as a result of battle damage (McCarthy 2016: 209; Anderson & Bigourdan in McCarthy 2016: 316), and is relevant to discussion as to the possible cause of wrecking being a fire or explosion in the coal cargo.

Figure 48 Hull plating surfaces showing extensive corrosion products, possibly related to heat/ fire damage (ATSB)

The ROV footage showing extensive corrosion patterns on the hull consistent with fire damage (whether as a result of spontaneous combustion or explosion) is one possible clue to the fate of IOS-002, though this is not conclusive.
